**NUMBER:** 08-054-14

Flash: RM4 UCONNECT AM/FM/BT/NAV/Voice Navigating Resets When Driving

2014	WK	Grand Cherokee (Japan Only)
2014	KL	Cherokee (Japan Only)

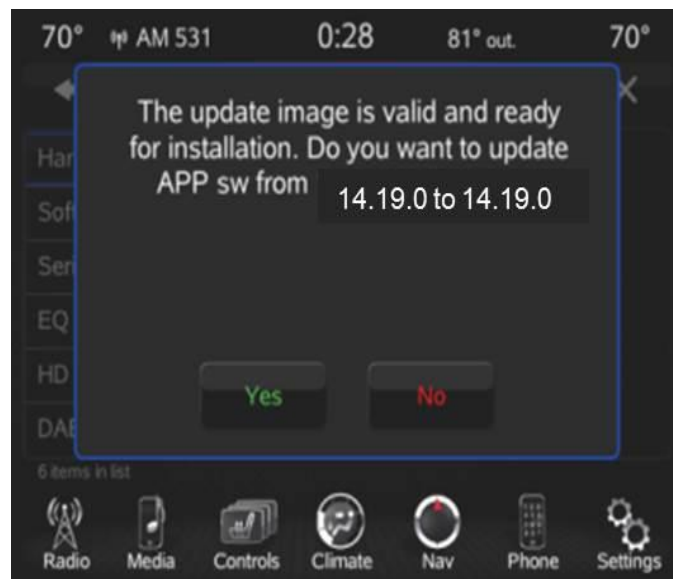
**Fig. 5 Radio**

**NOTE: Software levels shown should be the SAME (i.e. 14.19.0 to 14.19.0) verifying a successful re-flash.**

14. The Radio will power off and re-boot during and after the update.
15. Once the update is complete, wait for the radio to prompt for an update again.
16. Have you waited more than 20 minutes for (Fig. 5) screen to appear?
  - a. Yes >>> [Step #17](#)
  - b. No >>> Go to [Step #23](#)
