NUMBER: 23-025-10 REV A

Front Or Rear Window Bind, Stick, Tip's or Is Inoperative

2006-2007 KJ Liberty

2006-2007 KJ Cherokee (International)

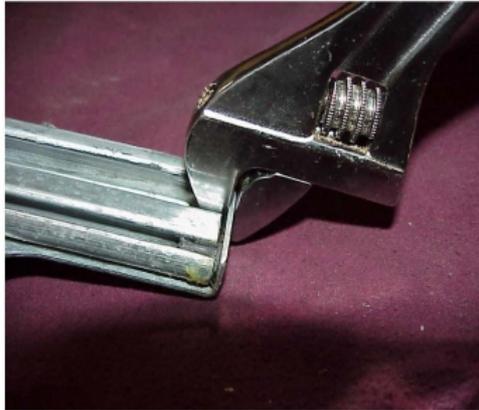
Fig. 1 Bend Rail Tab Down 90 Deg.

5. Use the 8 inch adjustable wrench to bend down lower Rail Bracket Tab 90° (Fig 1).

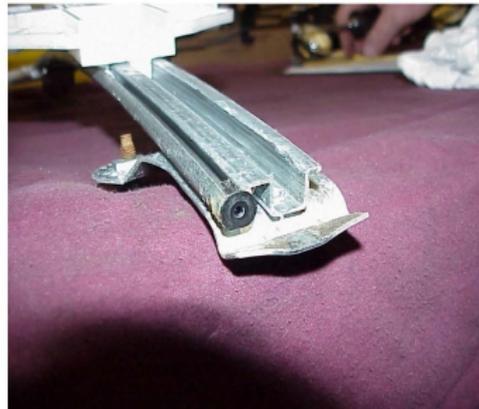
Fig. 2 Remove Plastic Bumper

6. Remove and save the small black plastic bumper located in the end of the rail (Fig 2).

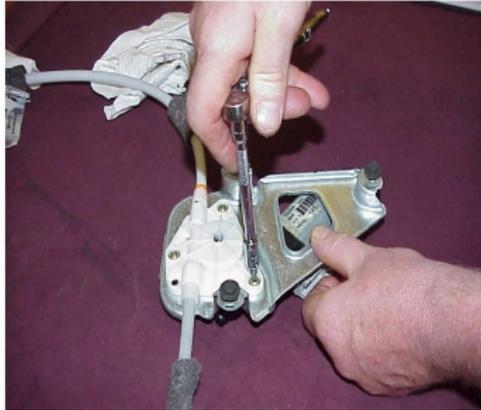
Fig. 3 Remove Motor and Bracket

7. Remove the three # 20 Torx screws securing the motor and bracket to the regulator drum. Keep the motor and bracket together for reassembly (Fig. 3).

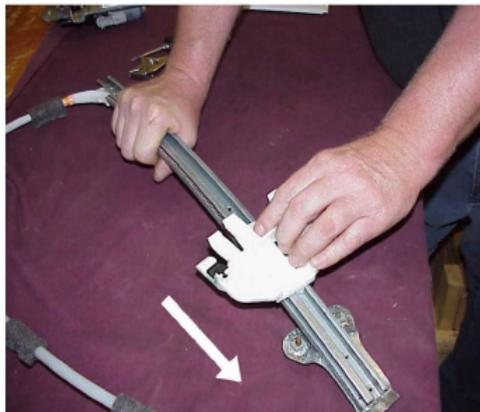
Fig. 4 Remove Old Liftplate

8. Remove the original lift plate and cable from the regulator and discard (Fig 4).

NOTE: If the cable is stuck in the drum housing. Push the cable forward to dislodge any debris or plastic chips that may be on the end of the cable in the drum pocket. Unscrew the cable counter clock wise if necessary to free up the chip or debris.

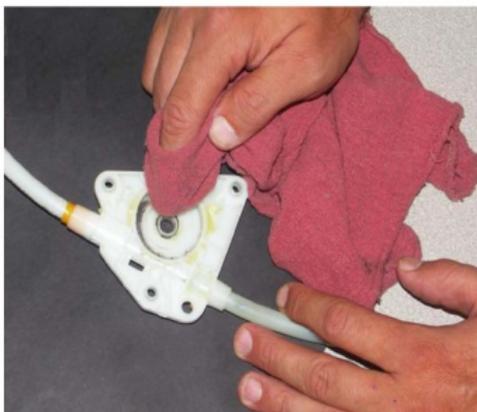
Fig. 5 Clean the Motor Drum Pocket

9. Clean the old grease, chips and debris in the Motor Drum Pocket and in the Rail cable groove with a shop rag (Fig 5).

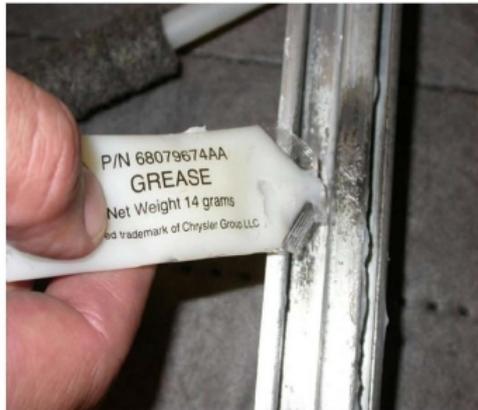
Fig. 6 Grease the Rail

10. Verify that the motor functions at the vehicle door connector.
11. Apply the supplied Grease in the following manner. (Fig 6) (Fig 7)
 - a. 1/4 packet into the Motor Drum Pocket.
 - b. 1/4 packet along the Rail contact locations.
 - c. 1/2 packet onto a paper towel and pull the cable through the grease.

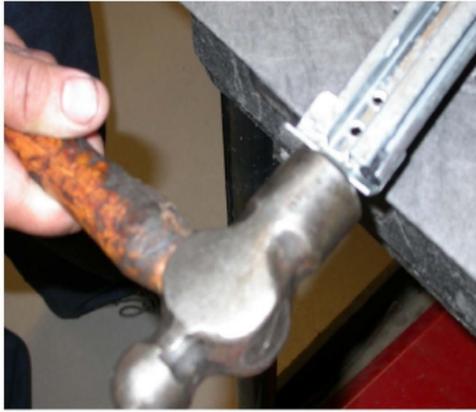
Fig. 8 Close the Rail Tab

12. Install the new lift plate cable assembly into the rail about 1/3 the way up the rail.
13. Install the motor and mounting bracket back onto the window regulator. Align the drum housing pilots with the motor bracket and motor (Fig 3).
14. Hand torque the screws to 2.5 Nm (22 in lbs).
15. Install the small black plastic bumper in the end of the rail.
16. Carefully bend the tab back up in its original location with the adjustable wrench. A hammer can be used to carefully tap the Bracket Tab into its final closed position. (Fig 8).
