REFERENCE:
ENG 3/2014/7

Model : Prado 150

Subject : Engine failure 1KD- FTV

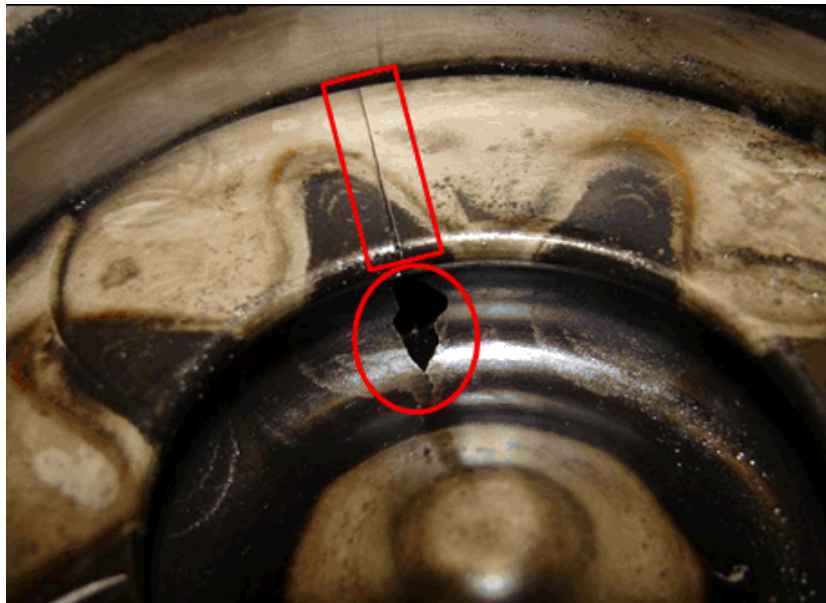
Fig 1: Picture one depicts a cracked piston on a 1KD engine which results in the above condition.

- All failed parts that were recovered for inspection revealed that the Pistons had cracked across the crown.
- In some cases the crack migrates from the crown down to the piston skirt through the gudgeon pin area.
- On some of the pistons a hole had developed on the lip of the combustion chamber recess.
- Small pin hole cavities were found on the surface of the piston crowns which are directly exposed to combustion.
- Close inspection of the cracked piston showed that each case, the crack started from a cavity located on the lip of the piston combustion chamber.
- The crack then spread across the piston crown and down the skirt.

The formation of these cavities is a normal occurrence. However, when they form on the lip of the piston combustion chamber, they causes a weak point from which a thermal stress crack may propagate.

The crack then leads to the eventual failure of the piston.

To increase the piston strength and ensure its durability despite combustion cavity formation, the piston shape has been change and the crown section thickened.

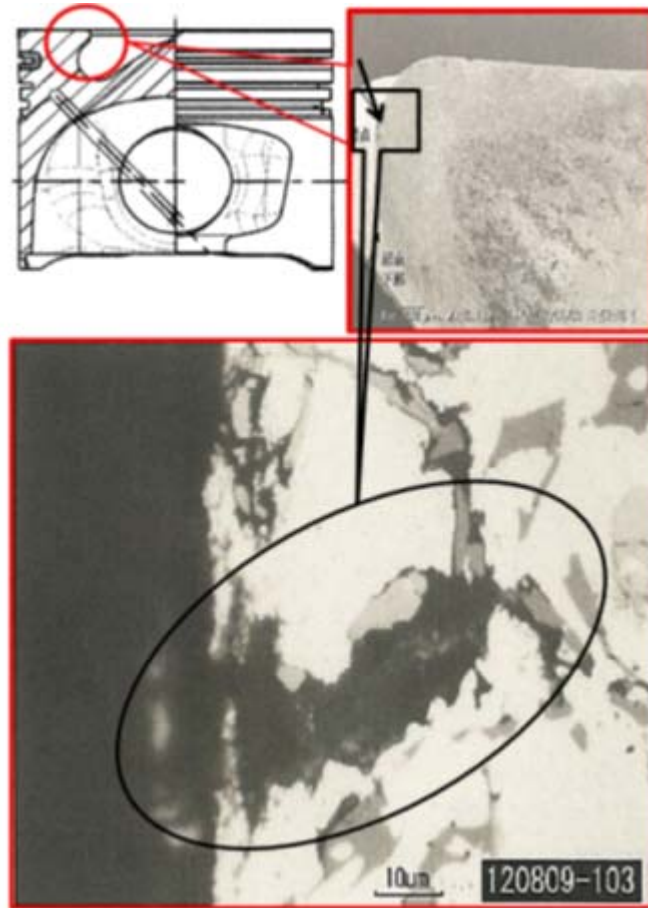
- Two types of cavities' were identified.
 1. Cavities caused during piston machining.
 2. Cavities caused by combustion action.
- Failed and unaffected pistons both showed machining and combustion cavities
- However, failed pistons had combustion cavities which formed on the lip of the piston crown combustion chamber.
- Unaffected pistons did not show combustion cavities on the lip of the combustion chamber.
- Therefore machining cavities were ruled out as a cause of failure.

Fig 2: Diagram showing a combustion cavity of the lip of the piston combustion chamber.

The formation of the combustion cavities occurs under high speed, high load and long durations operating conditions.
