A Gagg & Sons

Your Chronometric or Magnetic Speedometer / Tachometer may become damaged by the use of faulty or badly manufactured cables. The Inner cable may be too long, thus exerting pressure into the drive socket at the back of the instrument, resulting in the permanent damage. If such a cable is fitted, rapid damage will result.

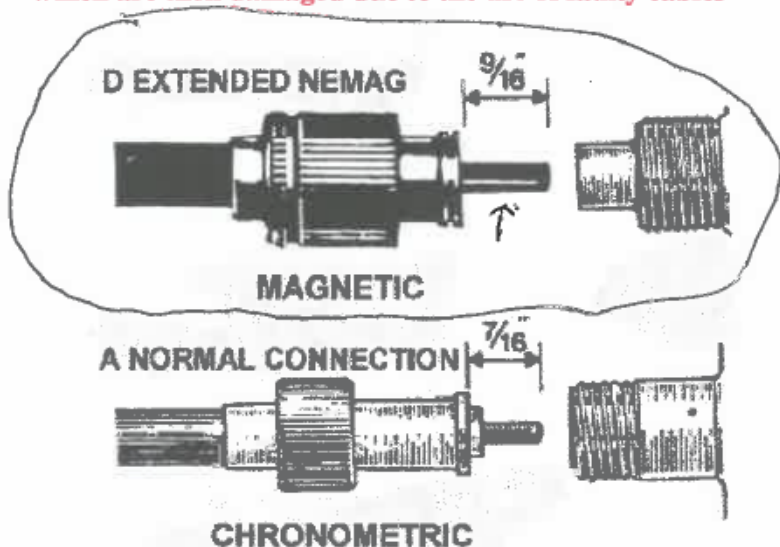
Then check that the amount of inner cable protruding at the instrument end is less in length than the depth of the drive socket on the instrument.

There must be free space, and the inner is not tight.

Check the drive end of the outer cable is properly fitted, and the inner cable end is firmly home into the drive end socket.

Also check to see if a small piece of cable has broken off and jammed in the drive end socket at the drive end.
