NUMBER: 11-001-15

GROUP: Exhaust System

Sputter Type Noise Emitted From Exhaust

2014 - 2015 (KL) Jeep Cherokee

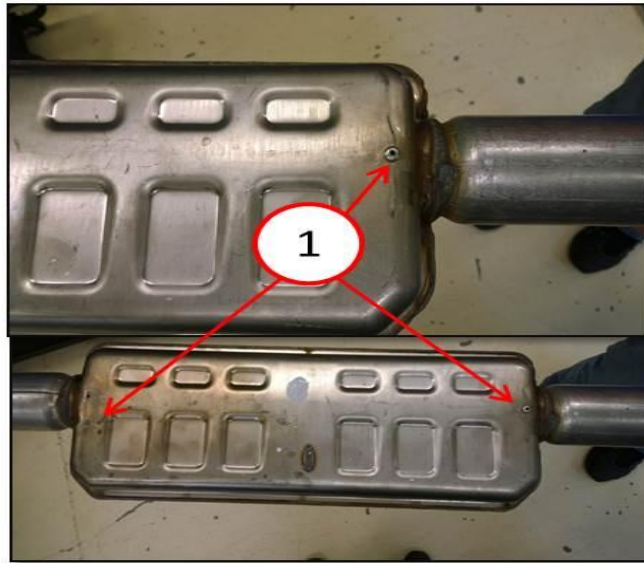
Fig. 1 Resonator Drain Hole

1. Inspect the resonator for drain holes, see (Fig. 1).

1 - Drain holes are located on both ends of the resonator.

2. Does the resonator have drain holes?
 - a. Yes >>> Proceed to [Step #3](#).
 - b. No >>> This bulletin doesn't apply. Normal diagnostics should be performed.
3. Replace the resonator, refer to the procedures available in DealerConnect> TechConnect> Service Info> 11 - Exhaust System Resonator, Exhaust/Removal/Installation.
